**COMMONWEALTH OF PUERTO RICO / OFFICE OF THE GOVERNOR
ENVIRONMENTAL QUALITY BOARD
EMERGENCY RESPONSE AND SUPERFUND PROGRAM**

**Re: Puerto Rico Containers (PRC) (a. k. a. Union Camp, International Paper Puerto Rico,
Puerto Rico Containers Company Limited, PRCC, ABC Containers)**
State Road 2, Km 15.2, Corujo Industrial Park, Hato Tejas, Bayamón

Included in this letter are the findings obtained during the Site Inspection of the PRC site. This investigation was performed by personnel from the PREQB Superfund PA/SI Division and included the review of all available information obtained from different sources (including the PREQB files), a target survey, various interviews, and a visual inspection performed at PRC on **March 17, 2005**. A sampling event was not performed during this investigation due to the conditions observed at the PRC site during the visual inspection performed on **March 17, 2005**. The site conditions observed will be described later in this Site Investigation (SI) Letter Report.

OFF / ON SITE RECONNAISSANCE PHOTO LOG REPORTING FORM

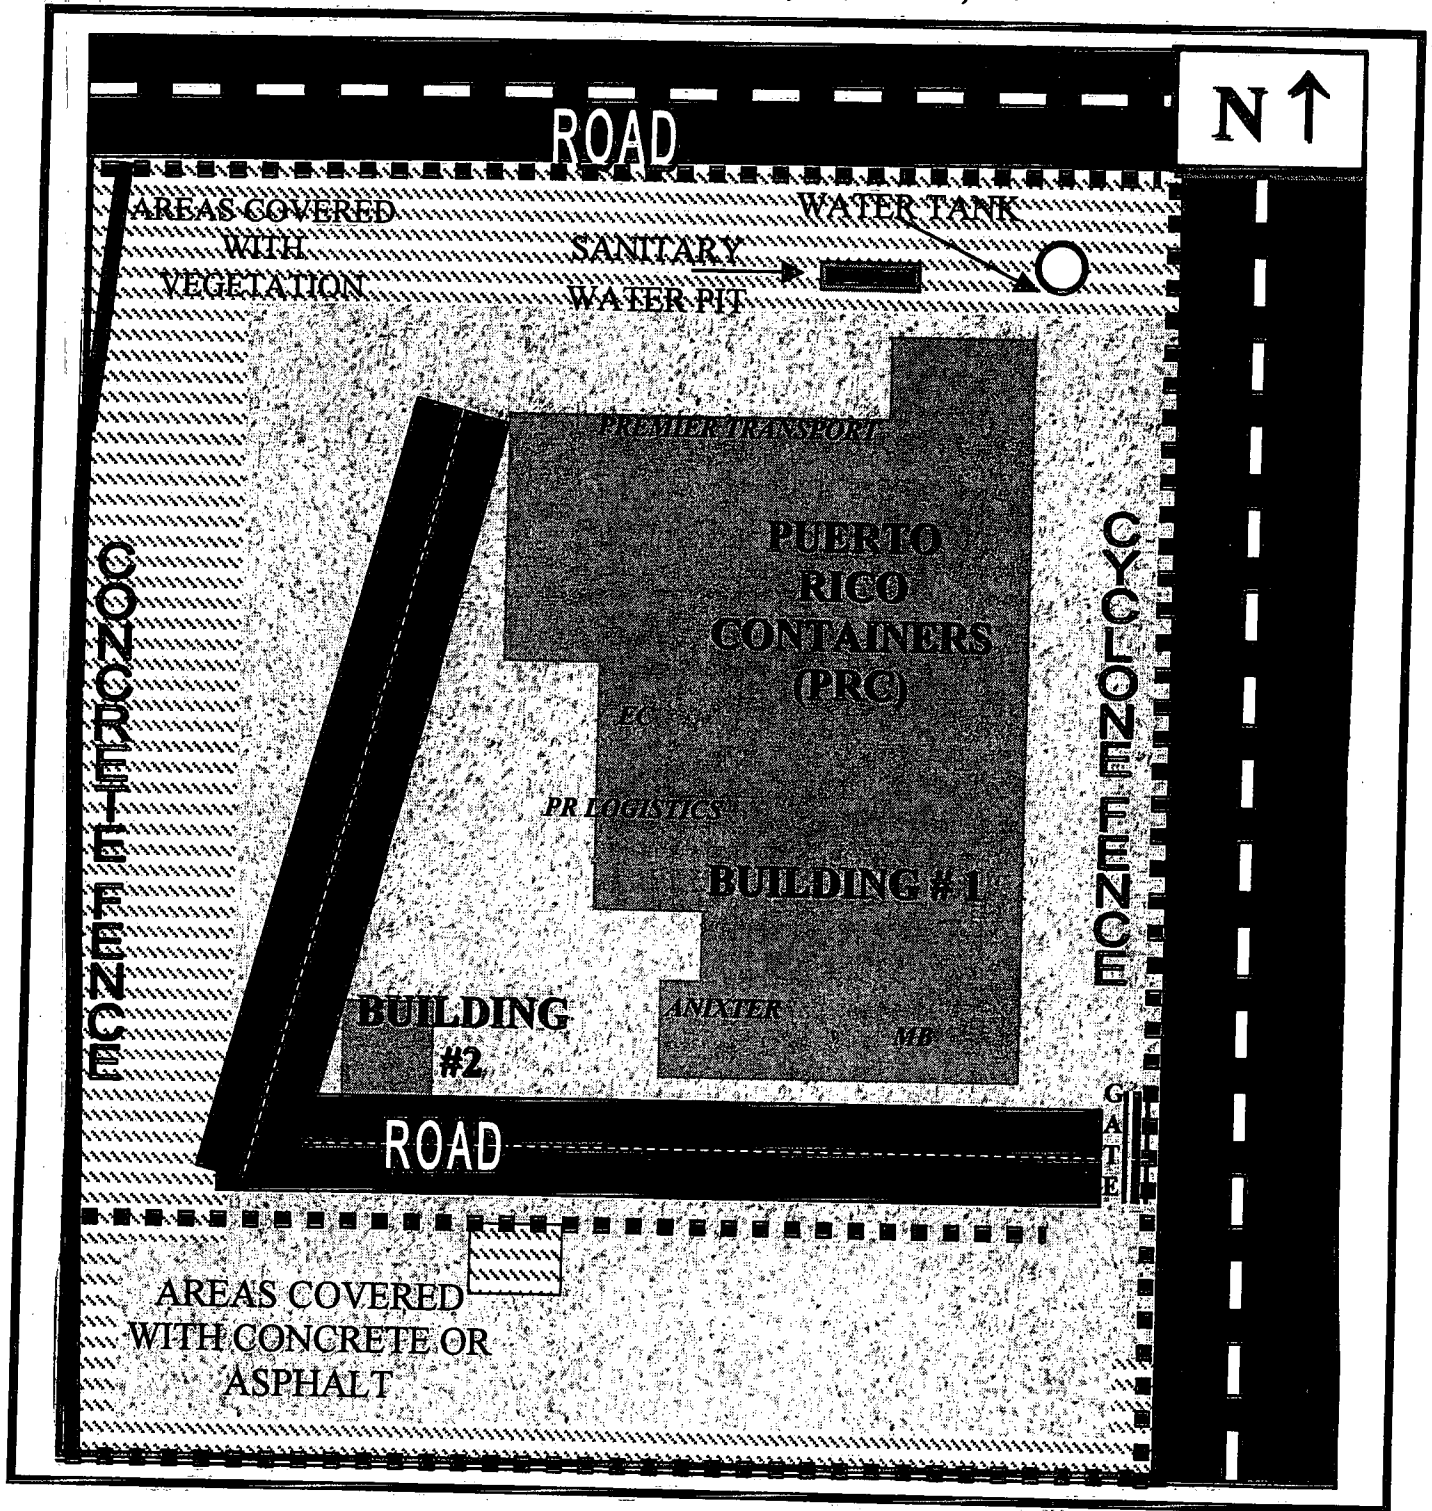
FIGURE 2: SITE SKETCH (2005)
NOT TO SCALE

Currently on site there is one (1) large one-story concrete building (building #1) in the center of the property and another small one-story concrete building (building #2) with a metal roof to the southwest of building #1 (Figure 2). When personnel from the PREQB Superfund PA/SI Division performed a visual inspection on **June 1, 2000**, (when International Paper Puerto Rico was still in operation) all the manufacture processes were performed indoors and there was a water treatment plant inside building #1. There were also two (2) 5,000-gallons above ground storage tanks (each inside a primary containment system and being used for the storage of petroleum and diesel, respectively) over an outdoor area covered with grass to the south of building #1, three (3) monitoring wells to the west of building #1 (near an area from where an underground storage tank was removed in 1993), and an underground septic tank (Figure 3).

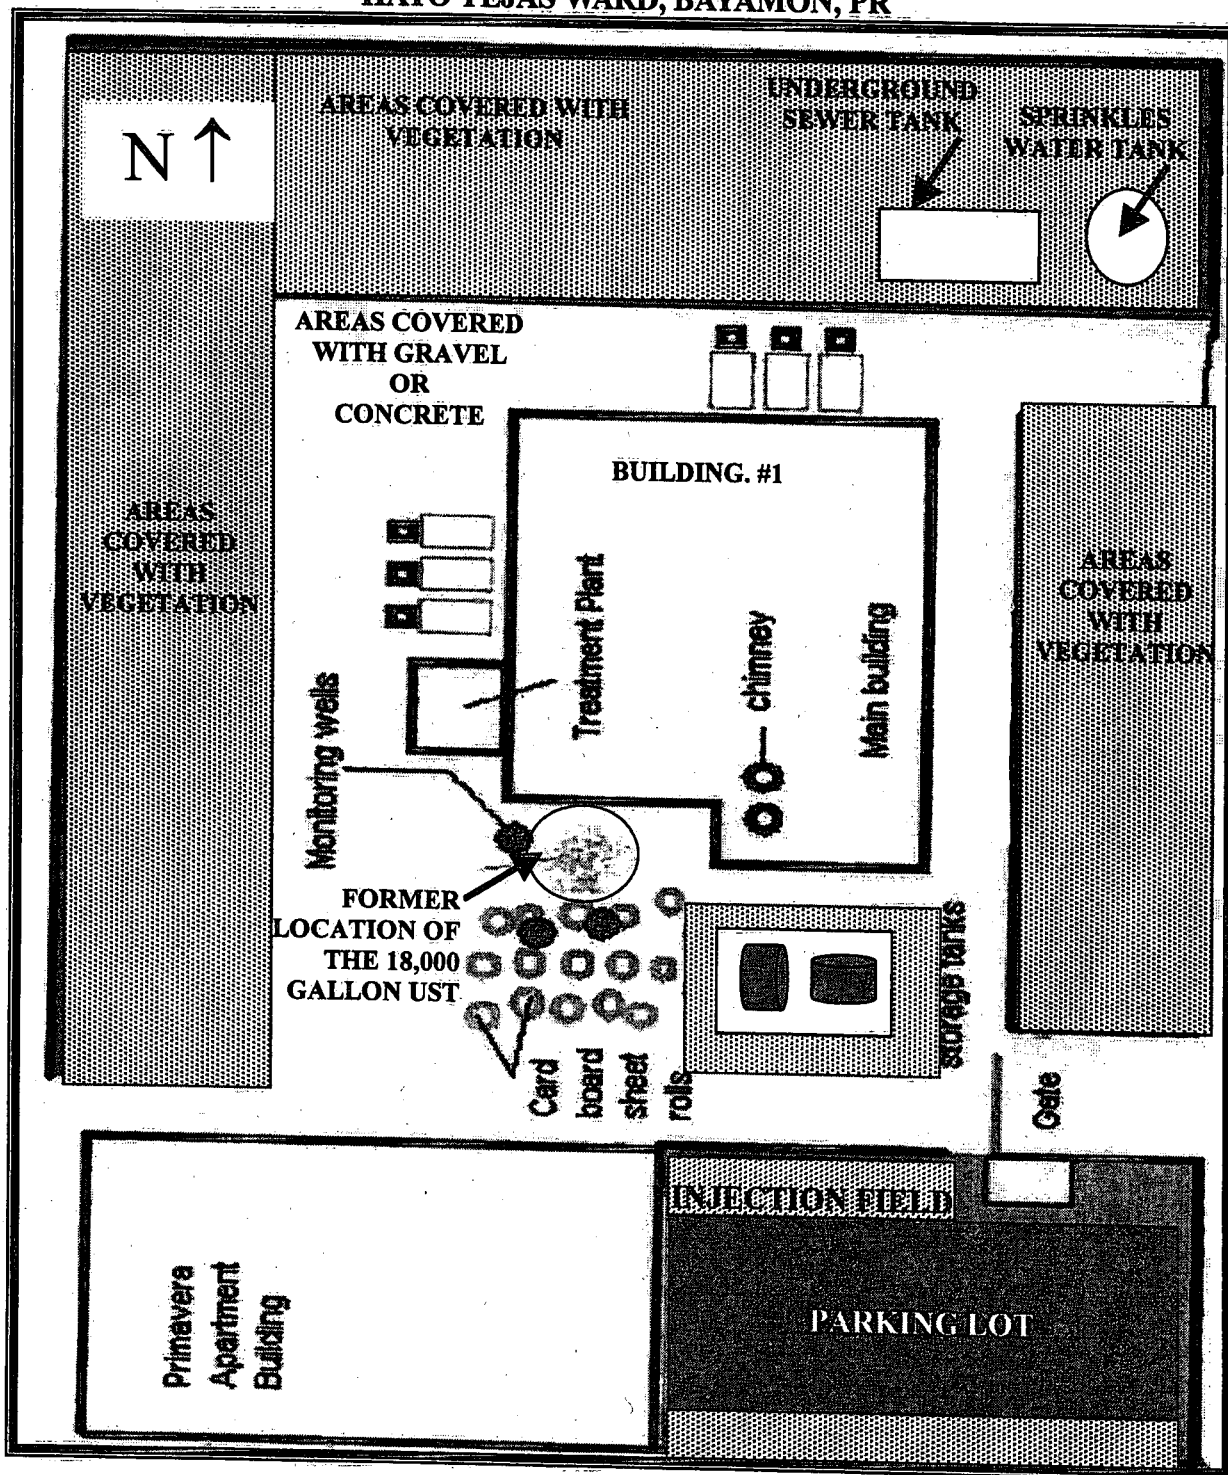
**FIGURE 3: SITE SKETCH (2000)
NOT TO SCALE**

The septic tank observed during a visual inspection on **June 1, 2000** was built in 1983 and is part of a Type V-C1 (according to the PREQB Underground Injection Control Regulation) underground injection system (UIC-92-0062). This underground injection system (UIS) consists of a septic tank of three (3) chambers with a capacity of 25,380 gallons connected to a system of twelve (12) underground percolating trenches. The twelve (12) underground percolating trenches irrigate an area of approximately 4,982 square feet (ft²) that is covered with grass and to the south of building #1 (Figure 3). Between 1983 and 1997, this UIS received process waters coming from the boilers room and the printing machines, water containing glue and oil residues, and all the sanitary waters generated on site. However, after 1997, as established in the PREQB UIC permit (UIC-92-0062), it was used exclusively for the disposition of the sanitary waters generated on site.

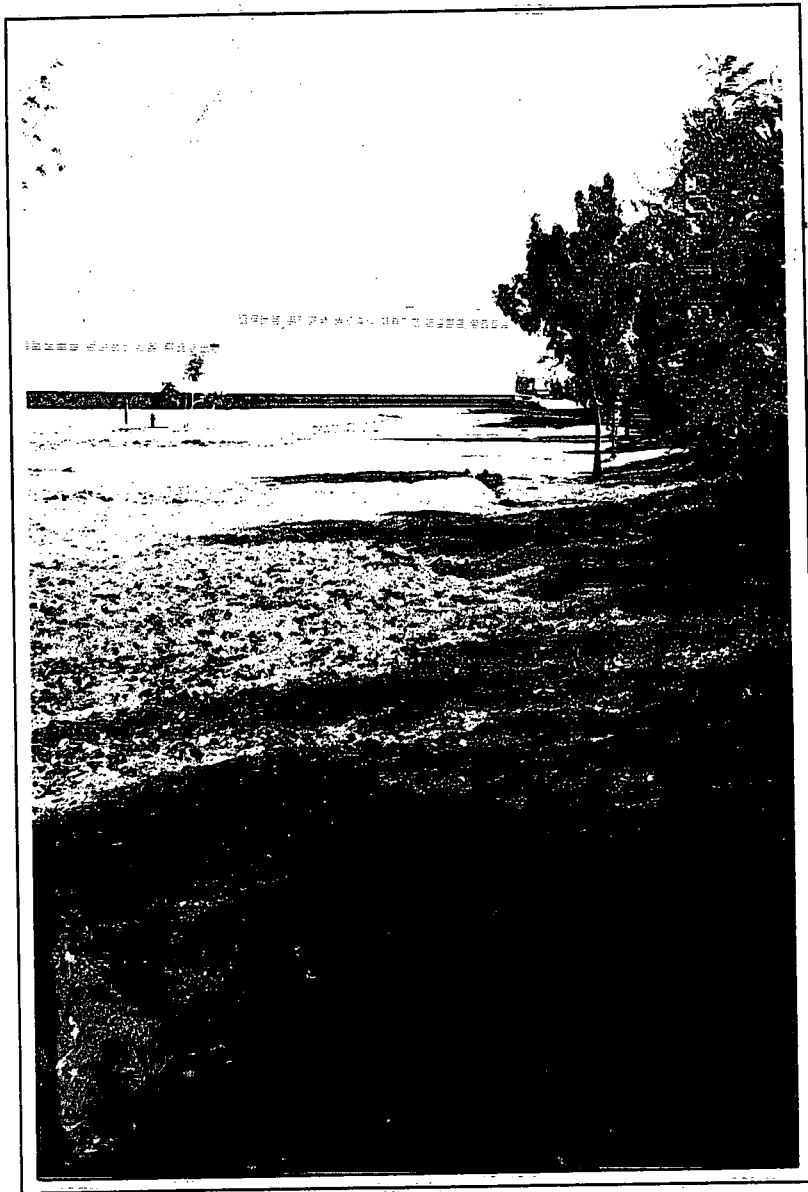
PHOTO 1

PHOTO NUMBER	TIME (HOURS)	DESCRIPTION
1	1543	View of the west side of the PRC's property. Photo was taken looking southwest from a large area covered with vegetation that is on the northern and northeastern side of the property. Observed that there is an asphalted road that borders the western side of the PRC's building #1 and reaches the northeastern side of the site. No stressed vegetation was observed in the large vegetated area described before.
2	1544	View of the northeastern side of the site. Photo was taken looking east from the northern corner of the property. A cyclone fence borders the eastern and northeastern sides. Observed that the vegetated area on the north and northeastern sides of the property begins at the fence and reaches a large shipping area covered with gravel and asphalt. This shipping area is adjacent and to the northeast of PRC's building #1.
3	1545	View of the shipping area located on the northeastern side of the PRC's building #1. Photo was taken looking southeast from the northern corner of the site. Observed a pile of approximately six (6) old used tires (i. e. truck tires) directly over the gravel (of the shipping area previously described) and next to hardware materials (e. g. metal racks, electrical cables rolls). Approximately ten (10) containers trucks were also observed in the asphalted area of the shipping area.

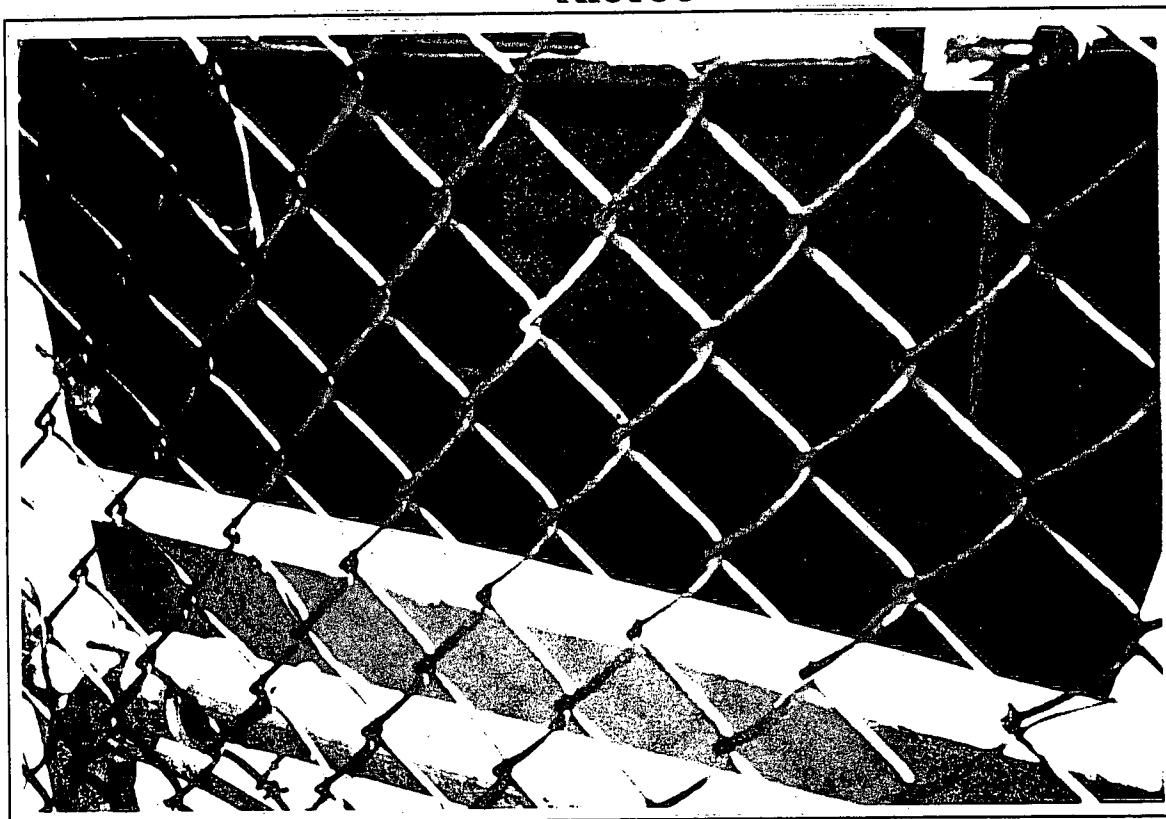
PHOTO 4

1544 hours Reached an empty concrete sanitary water pit located on the eastern corner of the property.

4	1547	View of an empty concrete sanitary water pit located on the eastern corner of the property. Photo was taken looking south and down towards the containment pit.

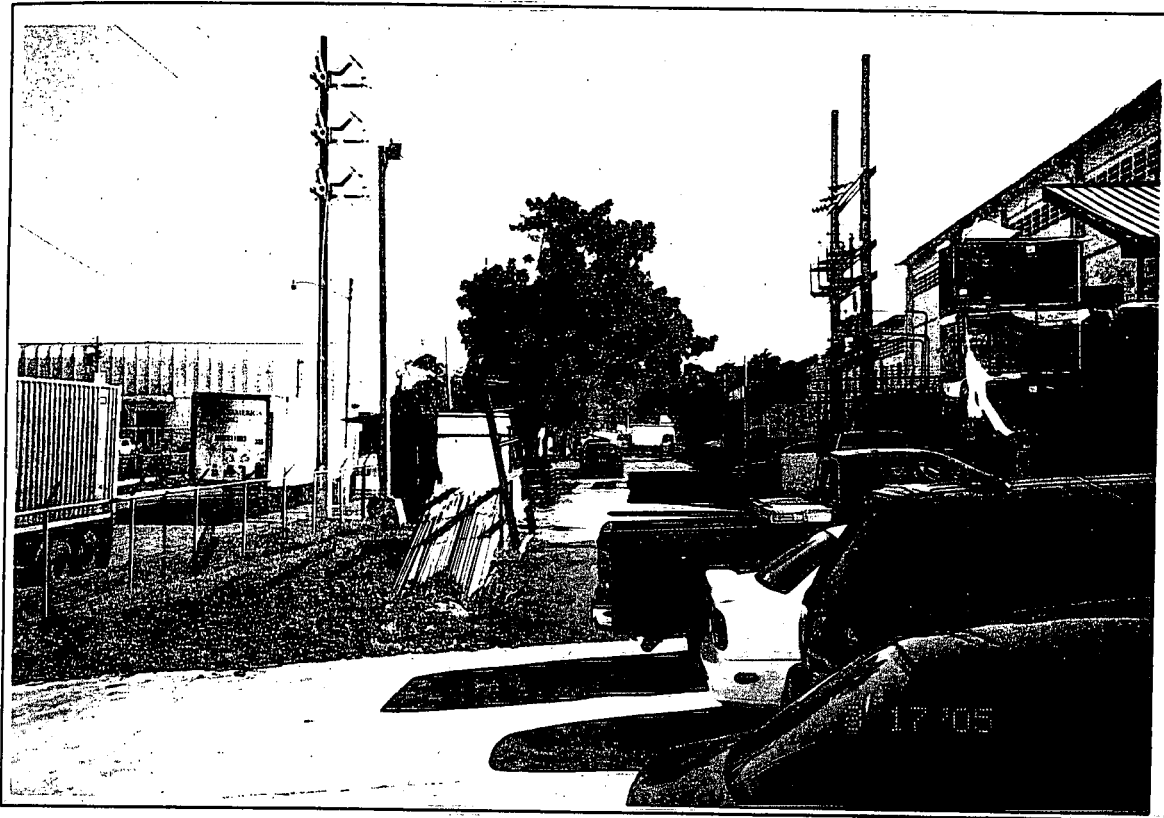
PHOTO 5

1545 hours Continued walking southeast to reach the eastern cyclone fence. Most of the superficial area along the eastern side of the PRC's building #1 is covered with concrete and asphalt, except for a small portion adjacent to and along the fence that is covered with vegetation. No stressed vegetation was observed in this area also.

PHOTO NUMBER	TIME (HOURS)	DESCRIPTION
5	1549	View of the eastern side of the PRC's property. Photo was taken looking south towards the cyclone fence bordering the eastern side of the site. Most of the superficial area along the eastern side of the PRC's building #1 is covered with concrete and asphalt, except for a small portion adjacent to and along the fence that is covered with vegetation. No stressed vegetation was observed in this area.
6	1550	View of the concrete covered shipping area adjacent and to the northeast of the PRC's building #1. Photo was taken looking north.
7	1555	View of a large area covered with vegetation on the western corner of the site. Photo was taken looking west. No stressed vegetation was observed in this area.
8	1556	View of the western side of the PRC's building #1. Photo was taken looking east towards the building. There is a small metal structure to the west of the PRC's building #1. Most of the superficial area bordering and adjacent to the northern and western sides of the PRC's building #1 is covered with asphalt and concrete.

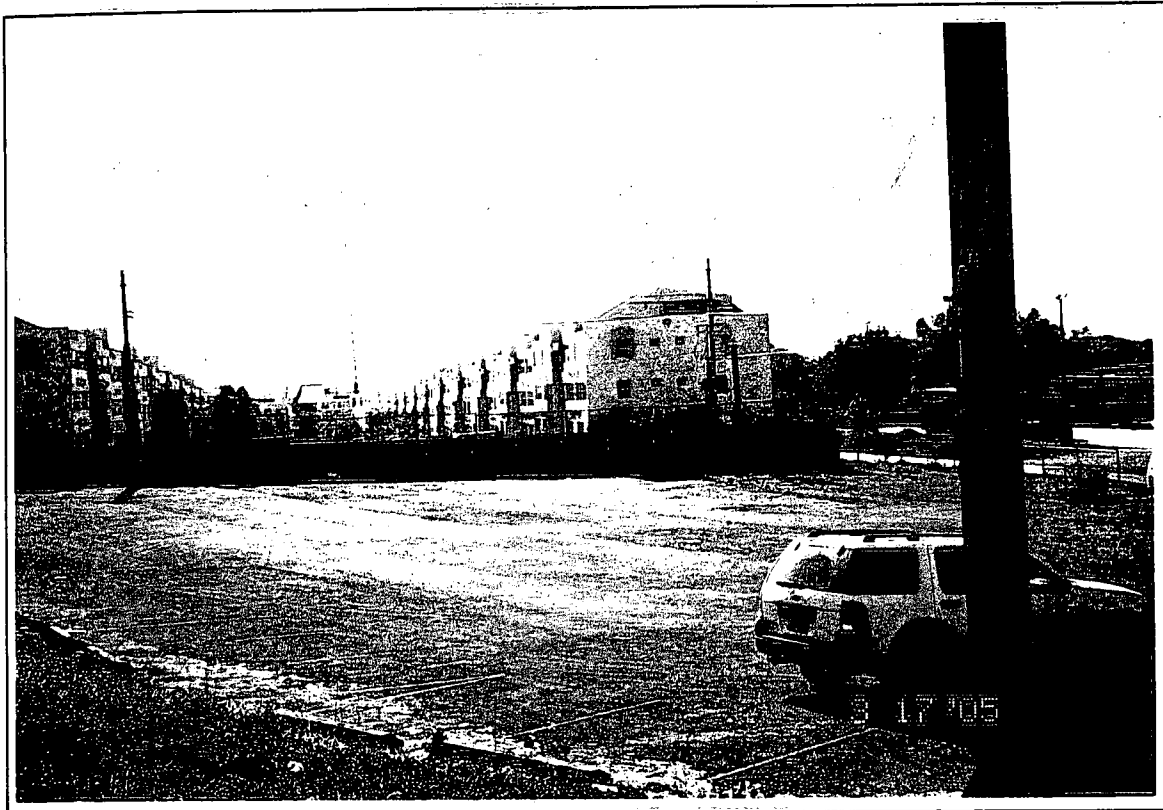
PHOTO 9

9	1559	View of the Primavera Apartment buildings that are to the west of the PRC site. Photo was taken looking west from the site. Observed that there is a large asphalted parking area to the west of the PRC's building #1. A concrete fence separates the apartments from the site.
10	1600	View of the south and southeastern sides of the PRC's building #1. Photo was taken looking north. Most of the superficial area to the south of the building is also covered the either asphalt or concrete as well as the parking area to the west of it.
11	1601	View of the northeastern side of the PRC's building #1. Photo was taken looking northeast towards the building. A cyclone fence also borders this side of the property.
12	1605	View of the northeastern corner of the PRC's building #1. Photo was taken looking southwest towards the site.
